# **Appendix D**

## **Anomaly, Failure and Mishap Reporting**

In accordance with NSTS/ISS 13830, Payload Safety Review and Data Submittal Requirements, the AMS-02 Project has prepared this summary of anomalies, failures and Mishaps associated with flight and qualification hardware. This summary does not consider what are considered normal manufacturing deviations and discrepancies as failures or anomalies unless they rise to a clear safety impact status. All such manufacturing discrepancies associated with the AMS-02 Integration Hardware built and procured through Johnson Space Center are documented in the JSC QARC system.

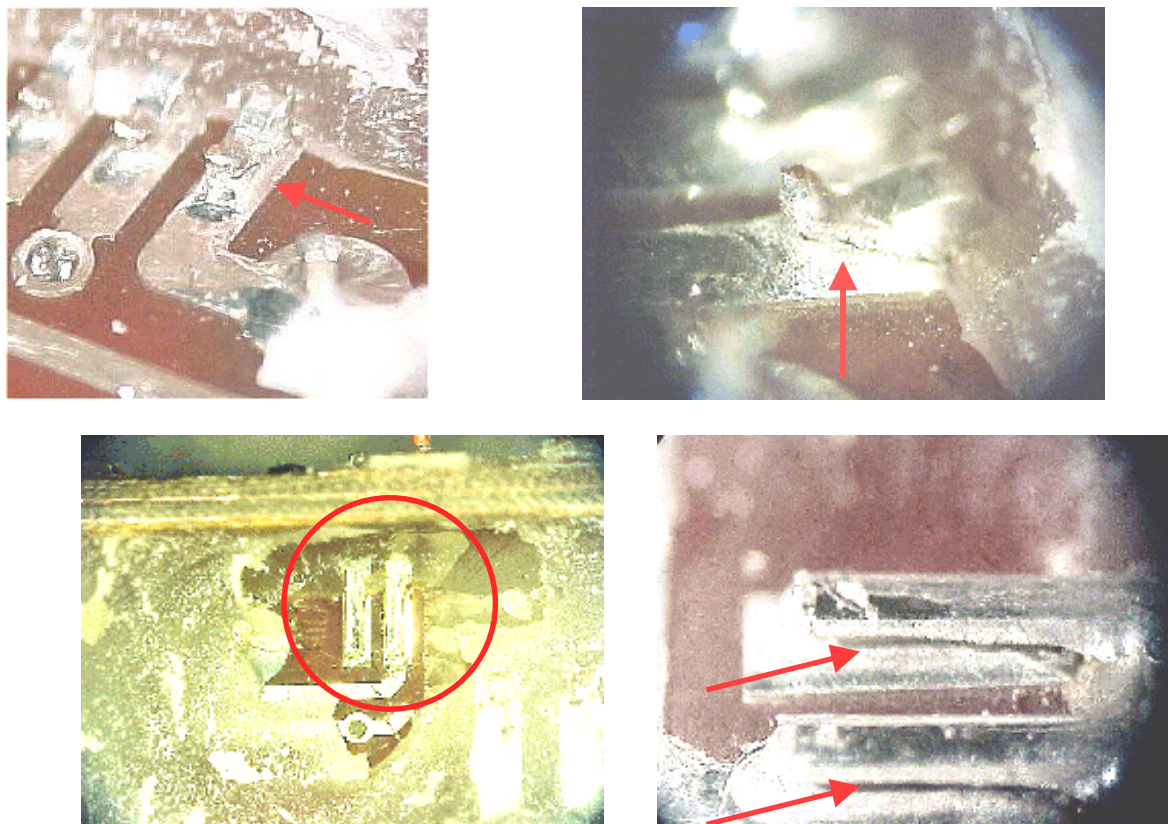
To investigate the problem, the TOF *brick* was dismantled and the Linear Regulators were carefully inspected. As a result, some of the SMD soldering of the straight pins were found to be broken, as shown in figure 3. According to CAEN, the failures were due to different thermal coefficient between resin and soldering material, generating a stress able to cause the connection rupture.

Figure 3 – Pictures of the pads where the *fork pins* were soldered.

**Corrective Action:** The straight forked pins interconnecting between the 16 mini-boards were replaced in a test configuration and qualification unit 2 with reshaped pins that provide a strain relief function that the straight pins could not provide. A test board has been constructed and tested at CAEN as follows: 1) burn-in for 8 hours with a temperature of 70°C ; 2) thermo-vacuum test with pressure of 0.1mBar, verifying the absence of discharges ; 3) thermal cycles (10 cycles in total between -30 °C and +70 °C, with a ramp-up rate of 4 °C /min, down-ramp rate of 2 °C /min and time of permanence at each temperature of 1 hour). At the end of each cycle, all the channels were inspected. No problem was observed.

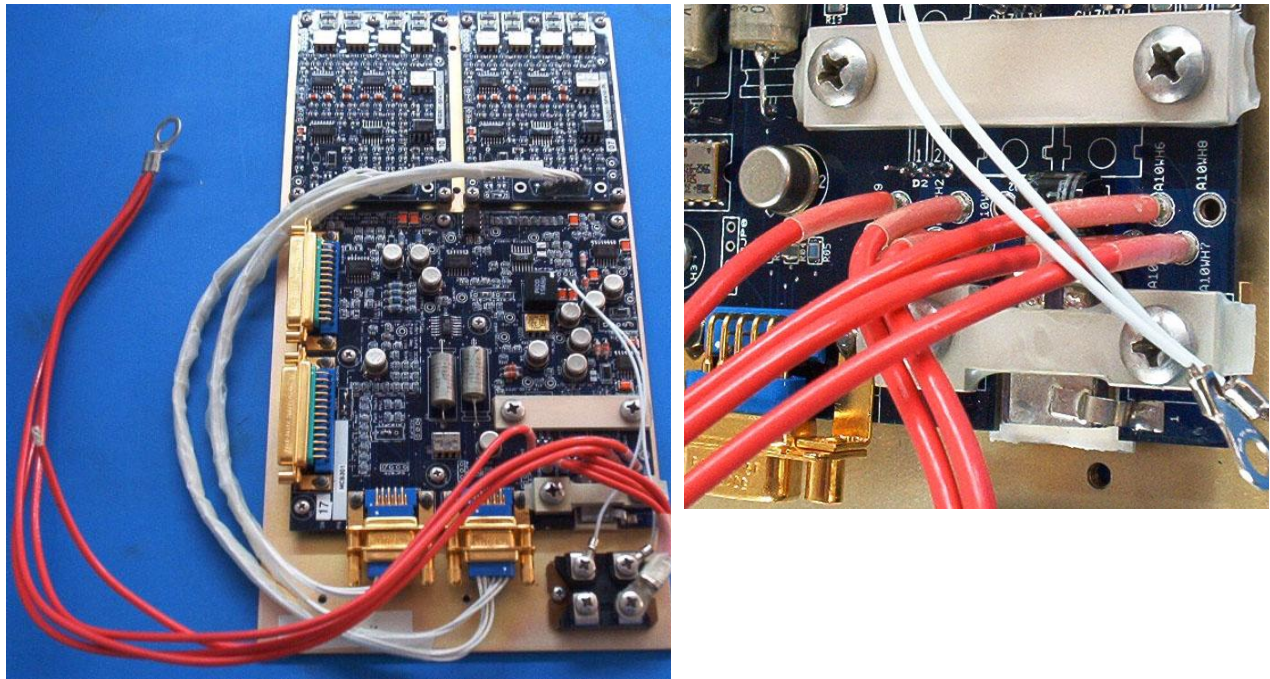
**Description of Event:** During the final system testing (2005) of the full electronics assembly at Eaves Devices, the last board (5<sup>th</sup> out of 5) tested failed the current interruption test (support 77A for 360ms to 1500ms). Upon examination of the board, it was discovered that the FET was cracked under the compression bar holding it in contact with the heat sink. These cracks apparently shorted the device, causing it to fail under high current. As shown in the attached pictures, the FET (located in the front right of the AMS BMS picture, near all the big red wires) has a compression bar over the top of it, holding it in contact with two layers of SIL-PAD and an aluminum heat sink. Per Eaves Devices assembly procedures, the screws on this compression bar are only torqued to 6 in-lbs.

Further examination of the other 4 boards revealed that the FETs in those boards showed signs of cracking, but had not failed any testing. (Initially report)

**Corrective Action:** Compression bar was eliminated from the design and a thermally conductive adhesive was used. Material usage was approved by JSC Materials. Thermal performance and board function were retested and found acceptable. Hardware was released from Eaves Devices after final rework and testing to confirm function.

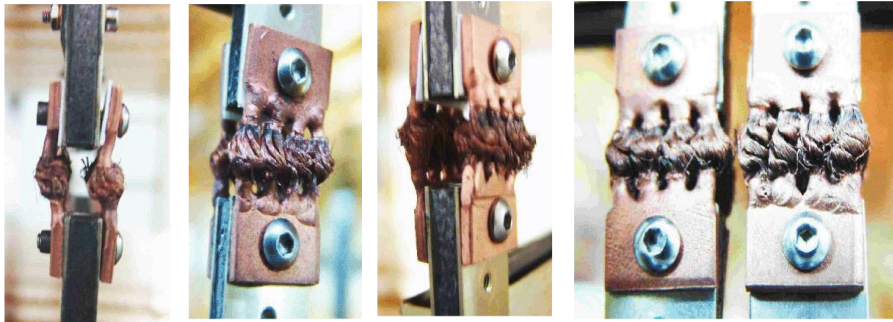
Observations: Some threads of the Copper braids used as thermal connectors between inner planes were found to be damaged during the assembly (*See Appendix A*). The damaged threads are broken on one side only and none was found to be loose. The loss of thermal conductivity is negligible.

This compression was performed *in situ* during assembly of the 3 planes of the inner tracker but before the definitive connexion. Some braids were damaged:

- Some weakness of the metal properties might have been introduced by the welding of the Copper braids
- The effect on thermal conductivity is negligible.
- The damaged threads showed a single break.
- No one was found to be loose.

Actions taken: Study of a containment procedure of the Copper braids using space qualified heat shrink tubing (*See Appendix B*). This tubing must be installed *in situ* after vacuum cleaning of the braids with examination of the filter. The heating should not damage the electronics.

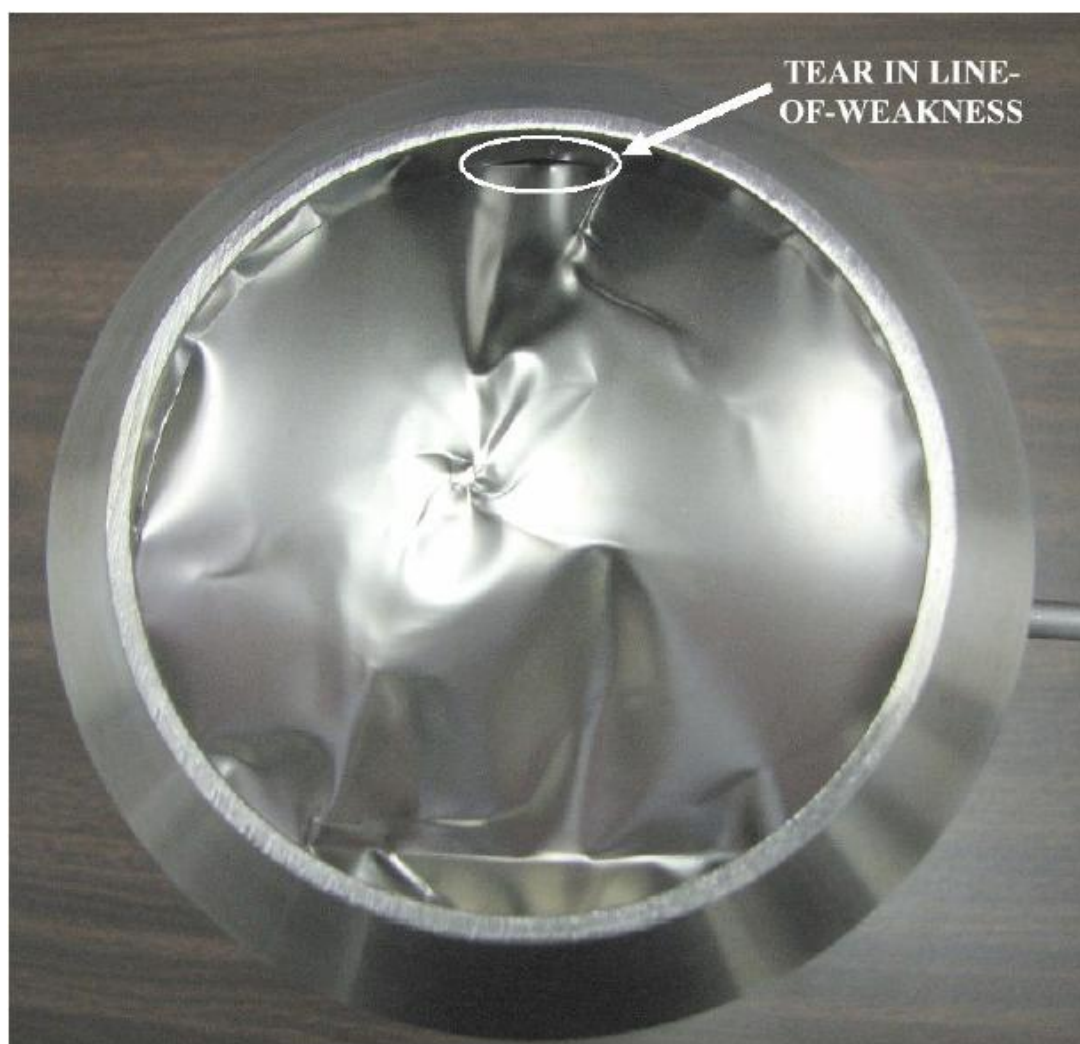
**Figure 4: Incomplete Tear of BD07B**

In the qualification burst of Units 1-4, BD07A ruptured normally, but BD07B failed to fully open. The disk membrane appeared to reverse, but did not fully tear. (This was confirmed when Unit 1 was cut open for a visual inspection of the disk, shown in Figure 4.) Airflow through BD07B was restricted enough that all air passing through simply vented through the interspace vent line. Air flow into the test volume was shut off at the sound of the event, preventing a renewed pressure rise.

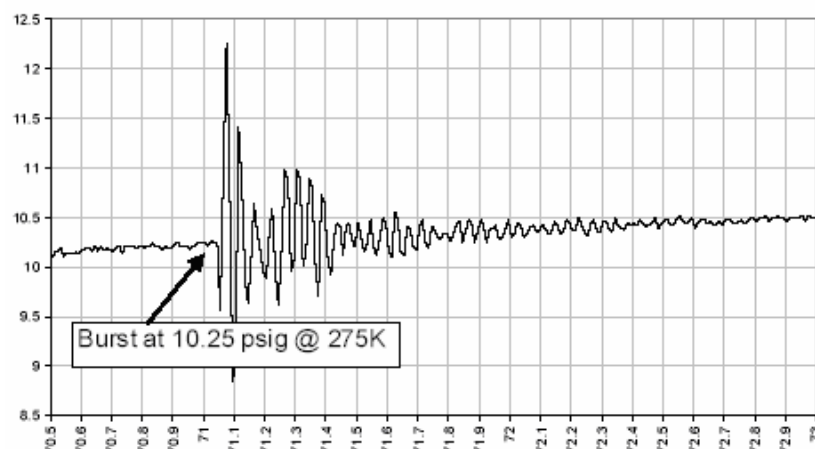
**Figure 5: Pressure v. Time for Unit 4 Qualification Test**

During the test of Unit 4, pressure taps recorded data at the inlet of BD07A and the interspace between BD07B and BD07C. The pressure data for the BD07A inlet is shown in Figure 5. Immediately after burst, there is a series of wide pressure oscillations ranging over nearly 3 psig at approximately 20 Hz. The cause of this oscillation is not immediately clear, but it is the likely cause of the anomalous behavior. The first spike at 12 psig is more than enough to reverse disk BD07B, but since it drops to less than 9 psig within approximately 0.05 seconds, there may not be enough energy to completely tear the disk along the score line. (The pressure measurements in the BD07B/C interspace did not show these oscillations.)

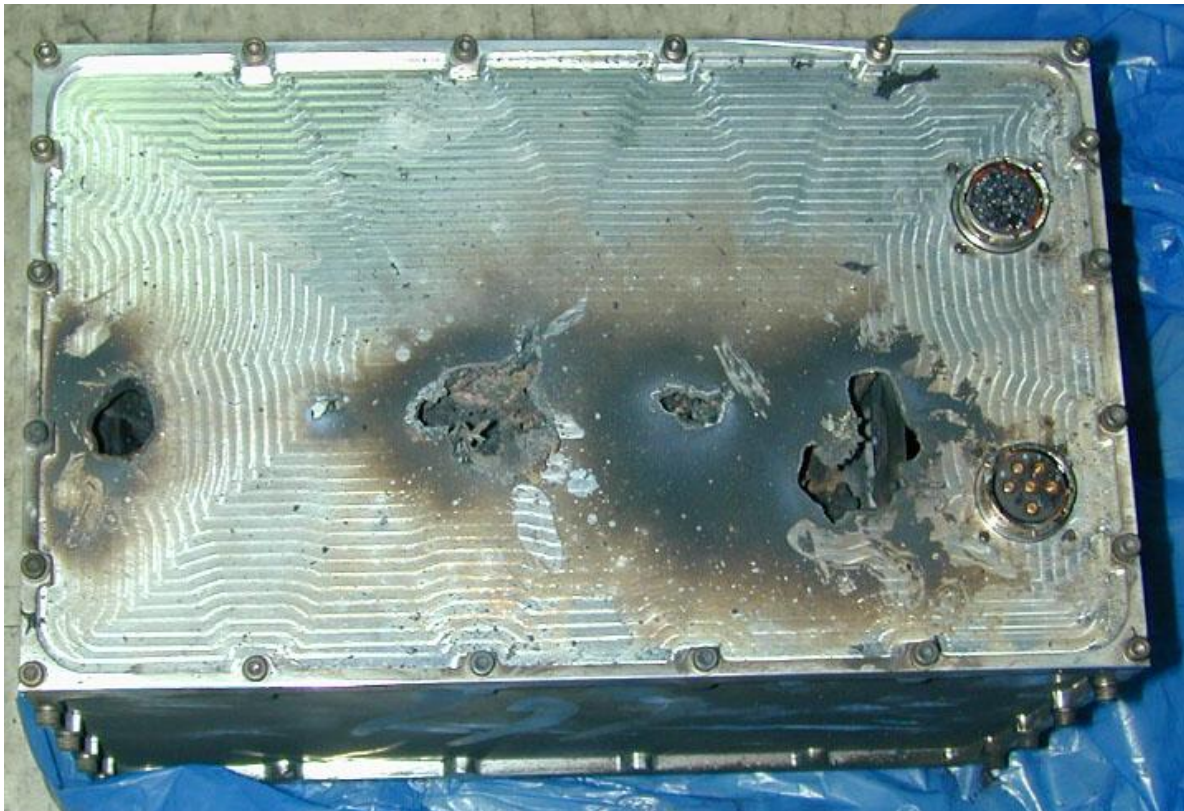
During testing, November 2006, of the AMS-02 Uninterruptible Power Supply (UPS) Engineering Development Unit at CSIST (Chung-shan Institute of Science and Technology) the battery assembly experienced a thermal runaway that resulted in a aggressive fire event that destroyed the UPS assembly.

Figure 11.1 – Engineering Development Unit (EDU) UPS after fire event.

**Corrective Action:** Upon review of the SYSU test set up and procedures, it was established that the charging system had not implemented the required controls to limit current or monitor battery performance that would have been enacted to compensate for the cell failure observed. Also at the time of the testing event, the testing engineers were absent. All remaining UPS units were returned to Yardney, the manufacturer of the cells and testing resumed at that location. See AMS-02-A12 for performance issues with remaining UPSs.

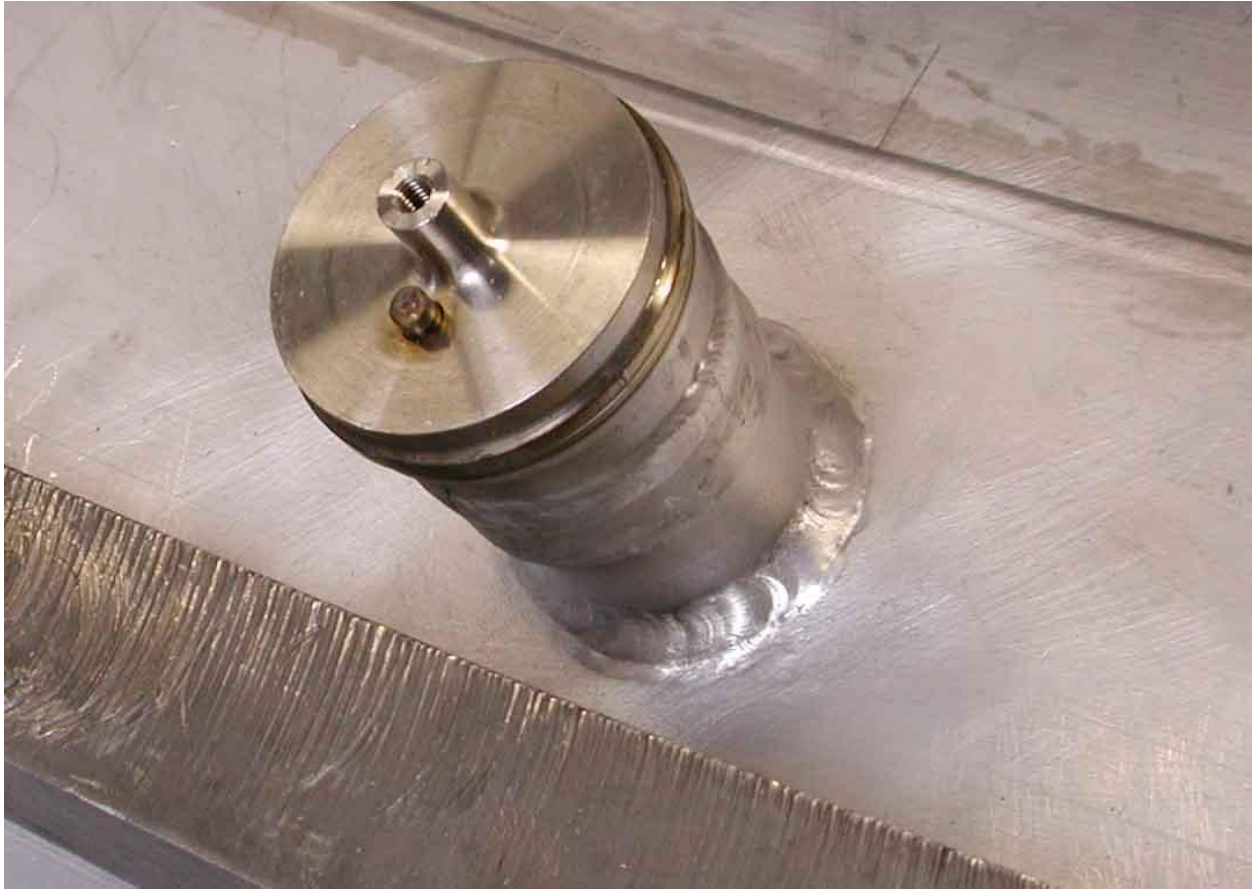
Figure A16-1 Replaced Bimetallic Joint in Place.

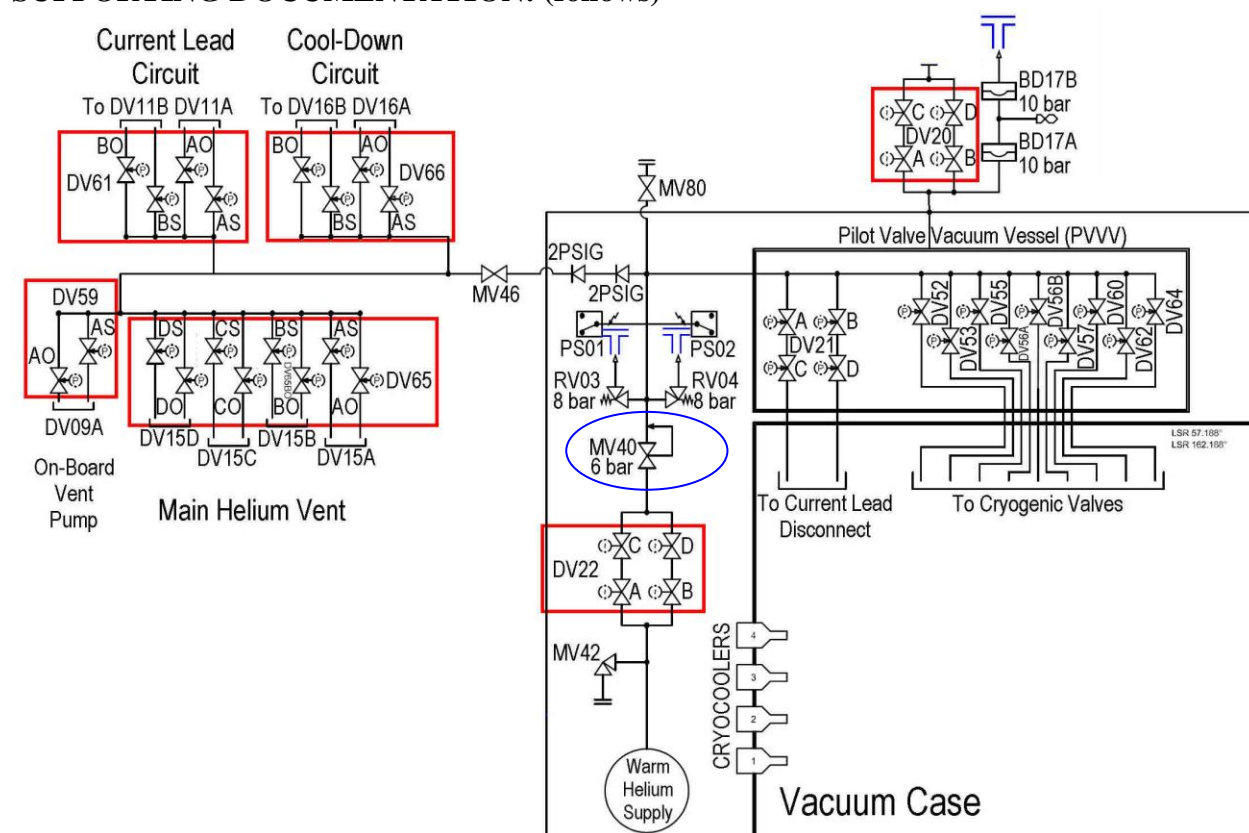
Figure A17-1 Warm Helium Gas Supply (Blue Circle indicates anomalous regulator)

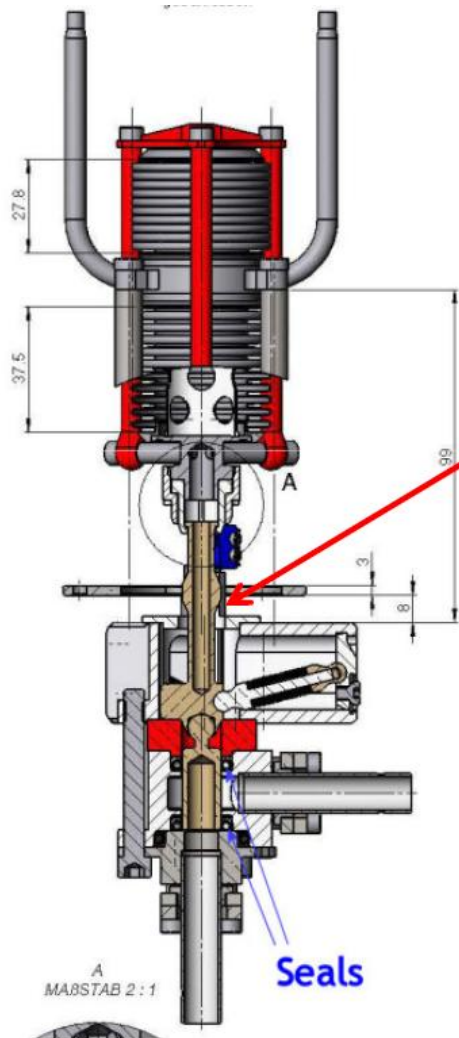
Leakage through stem  
between 10-4 and 10-8 mbarl/s

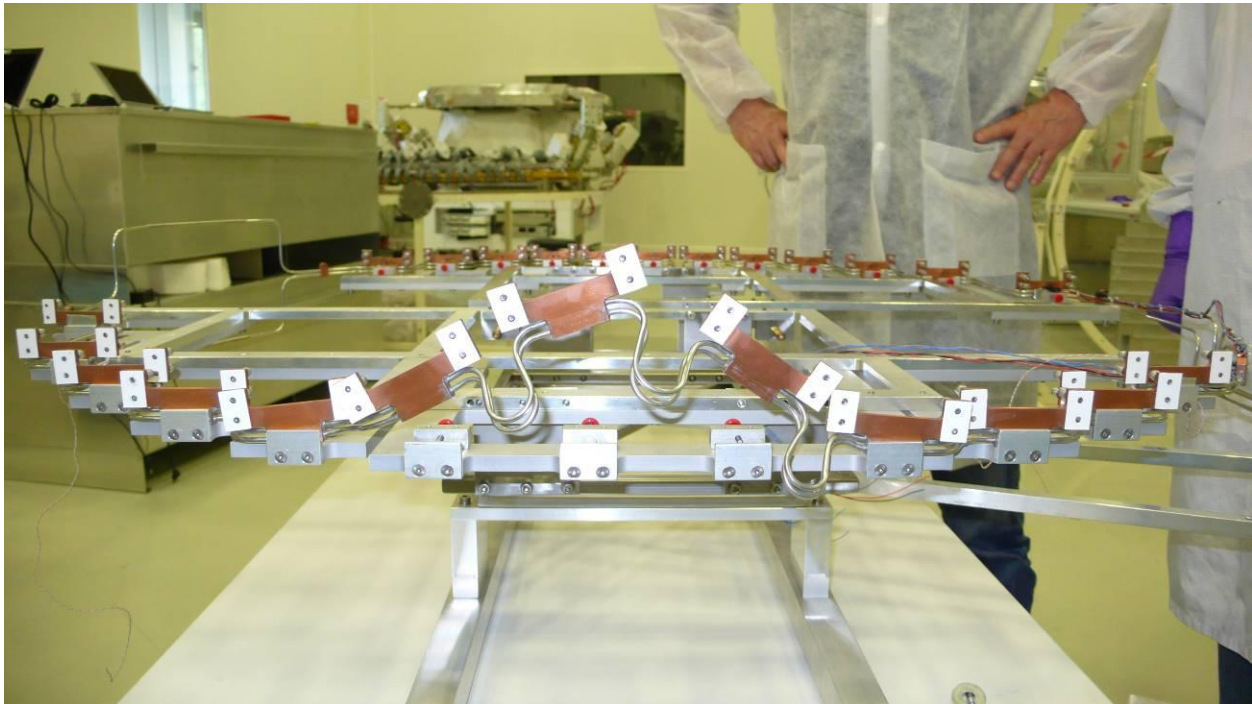
During deintegration the TTCS Evaporator loop was caught and bent out of its nominal shape. Note that the tubing is already bent into a complex shape demonstrating that the tubing is quite ductile.

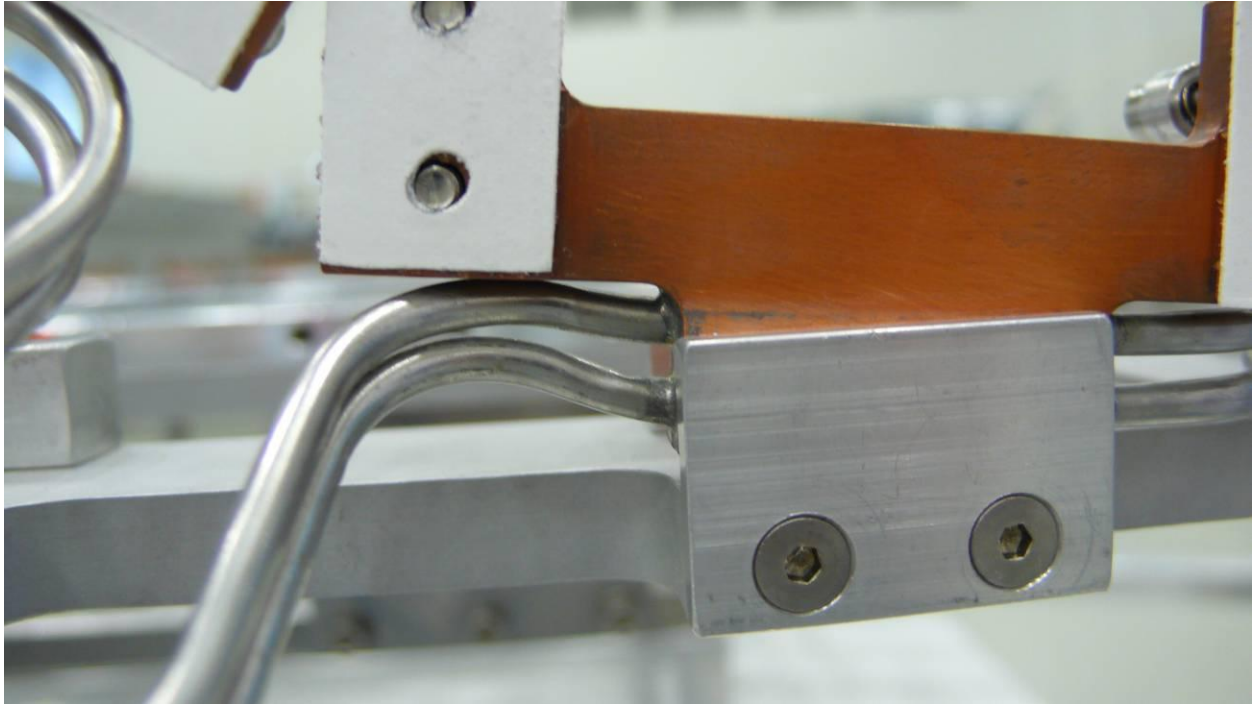
The point of concern was that there was something of a narrowing of the lowering pipe, described by some as a “kink.” This deformation was assessed and deemed not to have compromised the integrity of the piping.

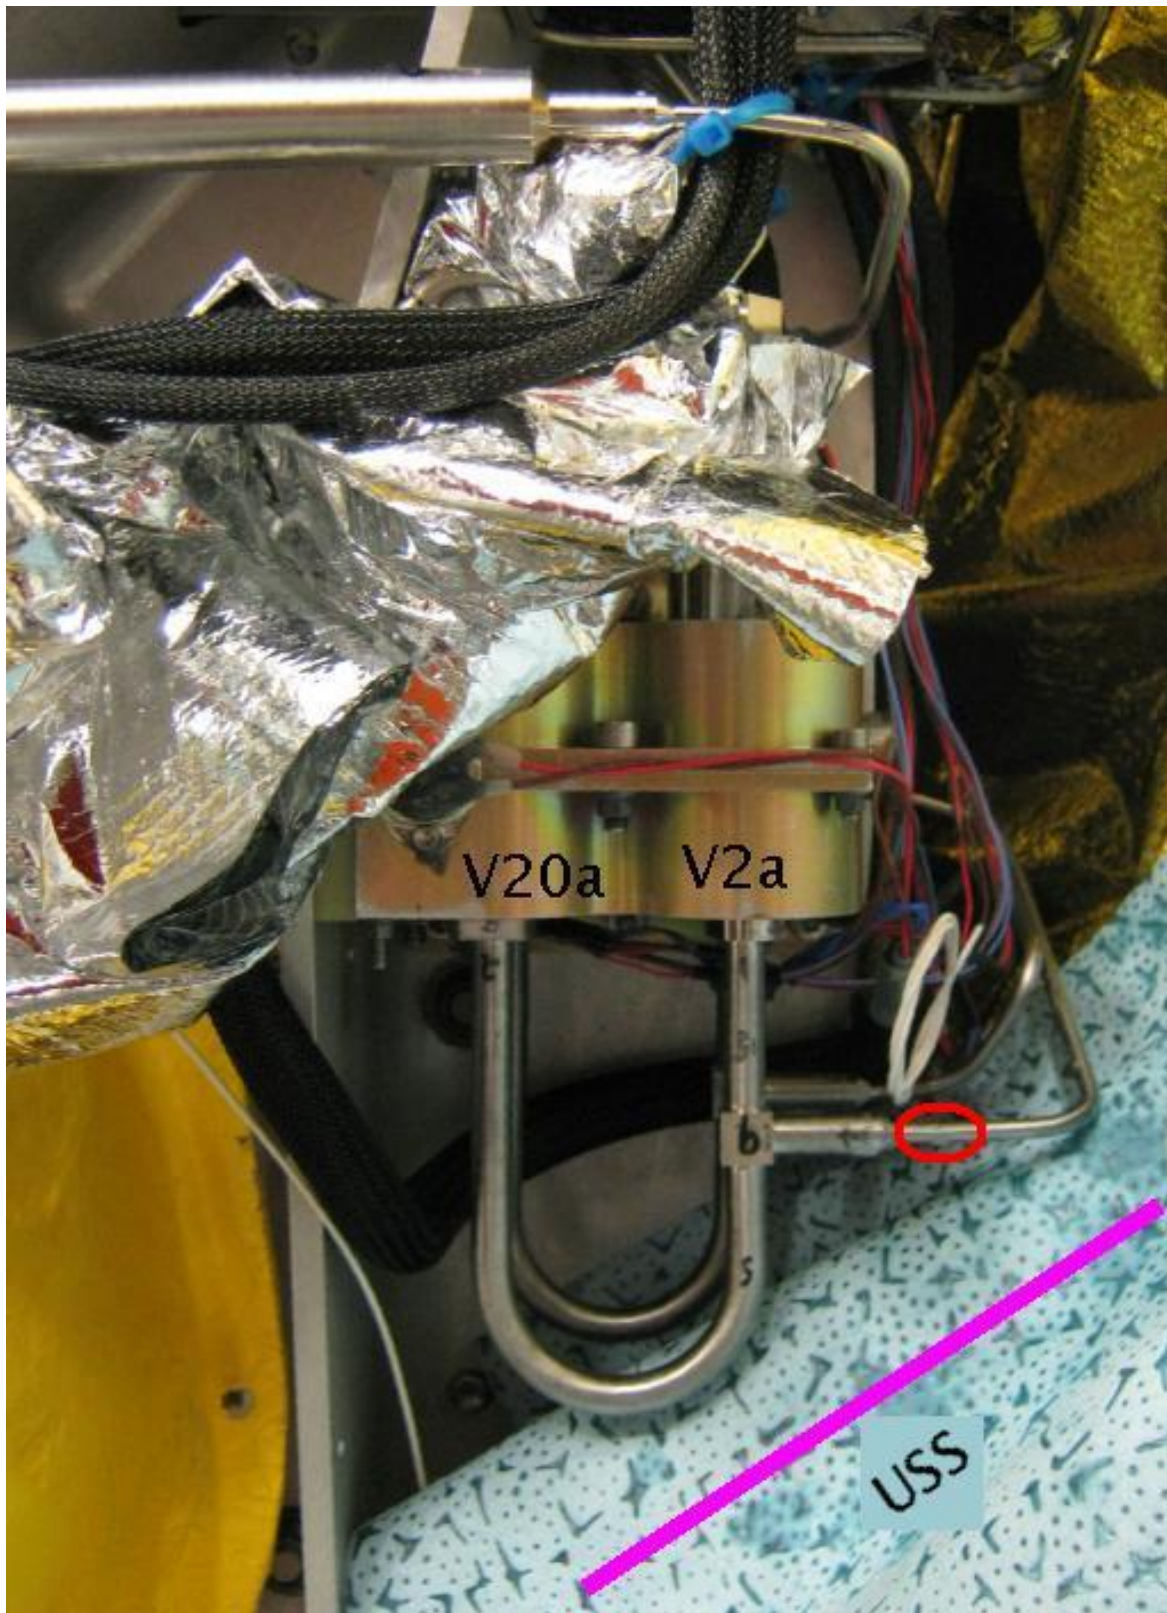
Location of TRD Xenon Leak

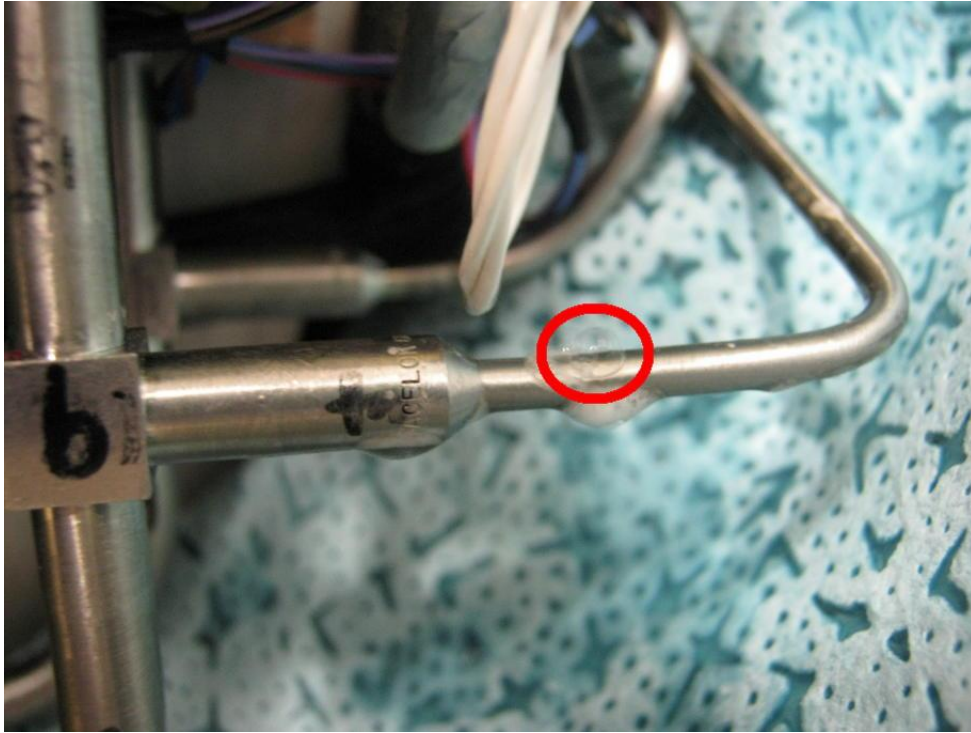
Specific location of TRD Xenon Leak

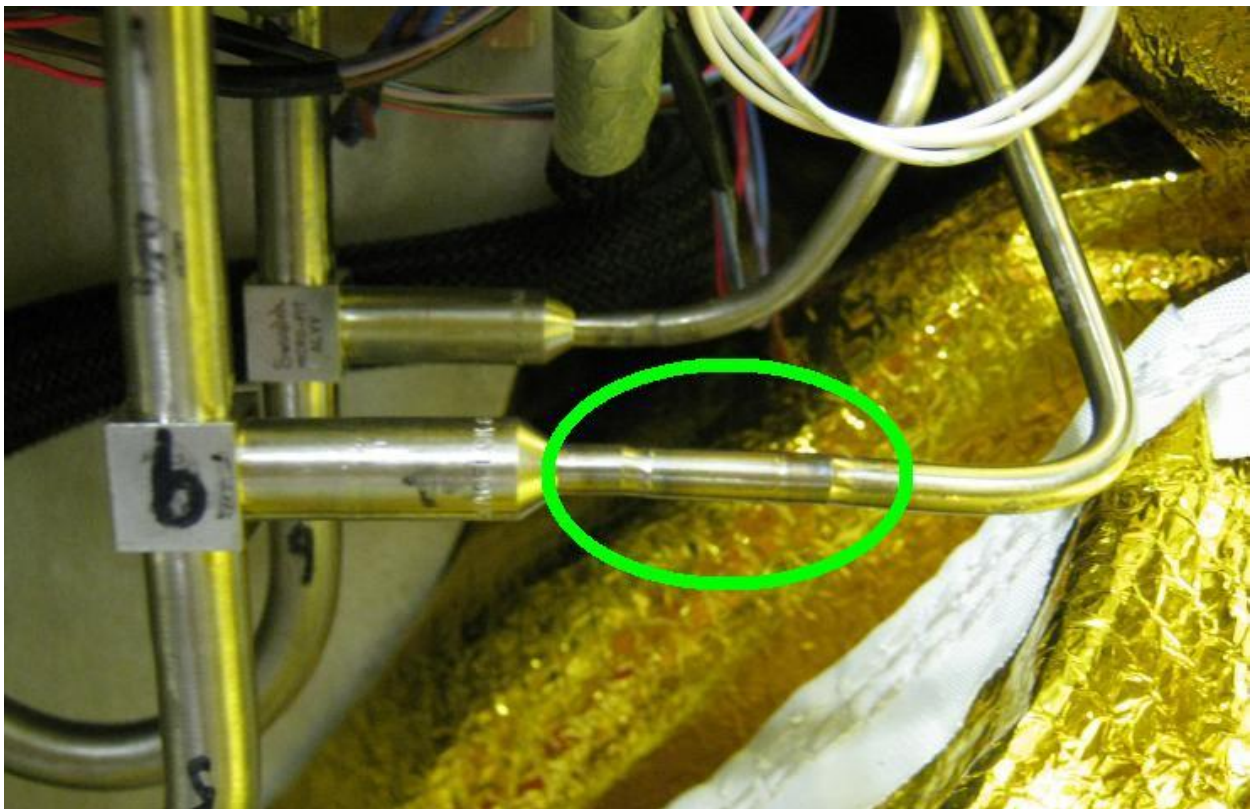
TRD Xenon Leak cut out and repaired.

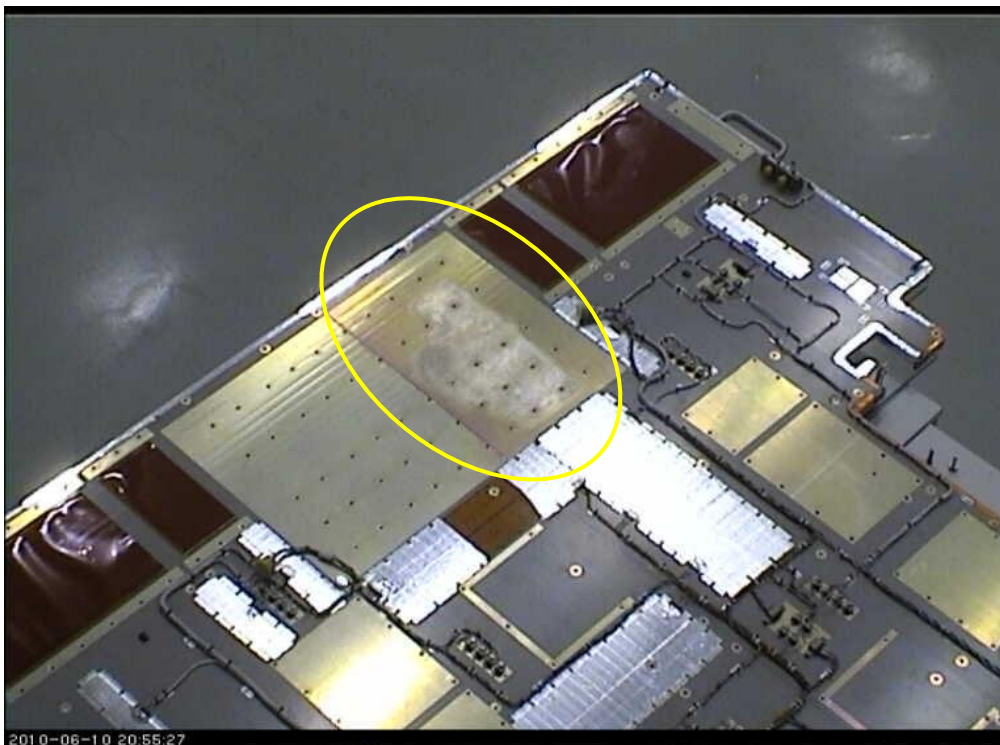
(below) Actual area where corrosion was located, not the division between the aluminum plate and corrosion only present on the right (upper) section. Holes are for #10 fasteners used to attach PDS box.

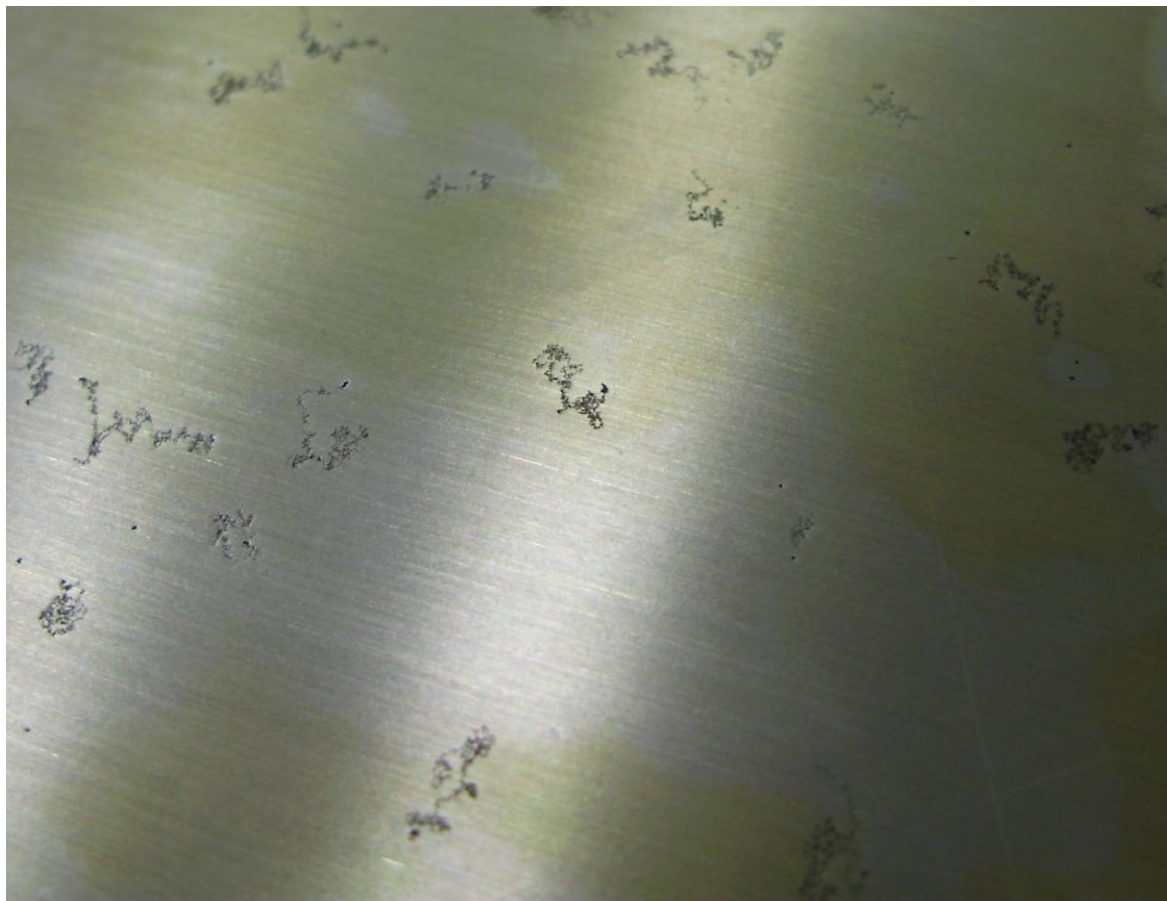
Close up photograph of “Worm Track” Corrosion in 0.5 mm Al 2024-T81 Aluminum Face Sheet (Alodined Surface) WAKE Radiator.

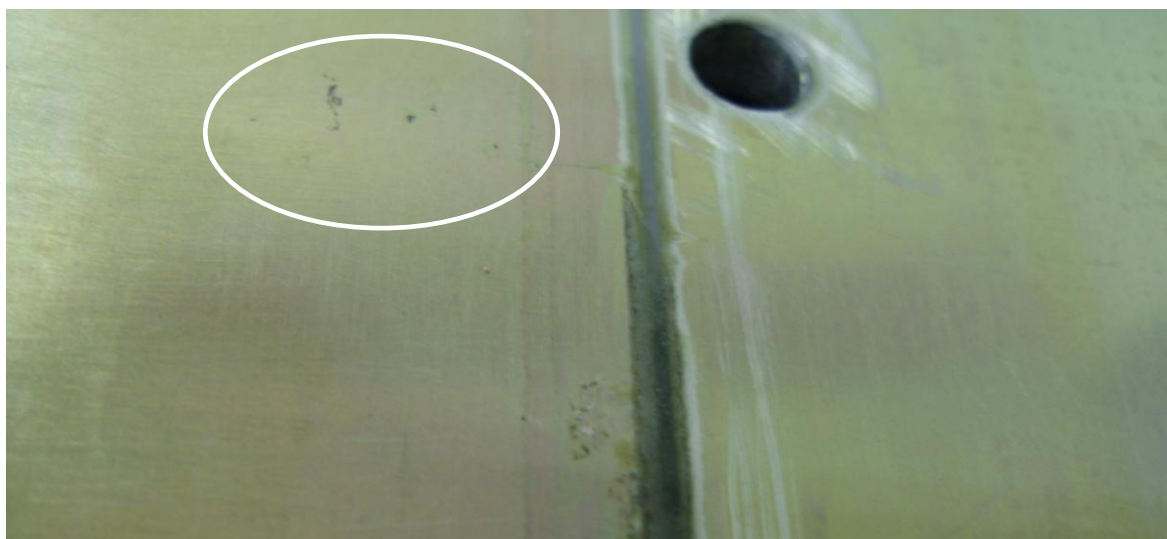
“Worm-Track” Corrosion locations (near pixel level in this photo) show in comparison to a mounting hole for a #10 fastener. Also note that the corrosion is only on left sheet, the right sheet was covered in an identical manner by the same avionics box but did not develop corrosion.

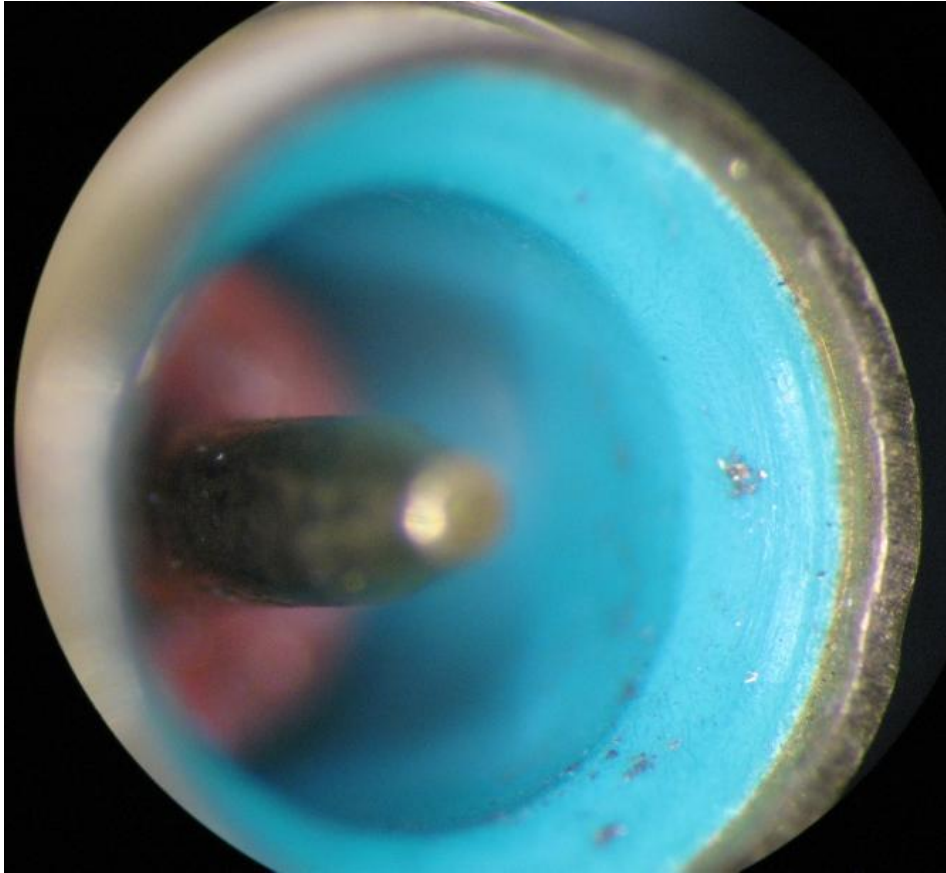
Example of gold fleck debris

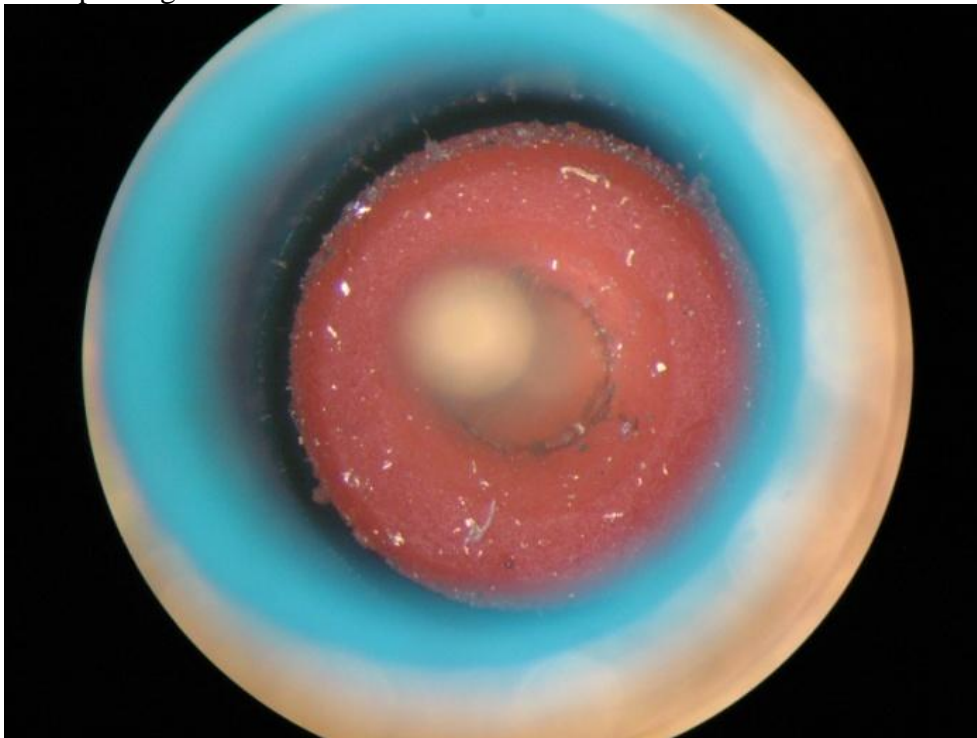
Example of gold fleck debris

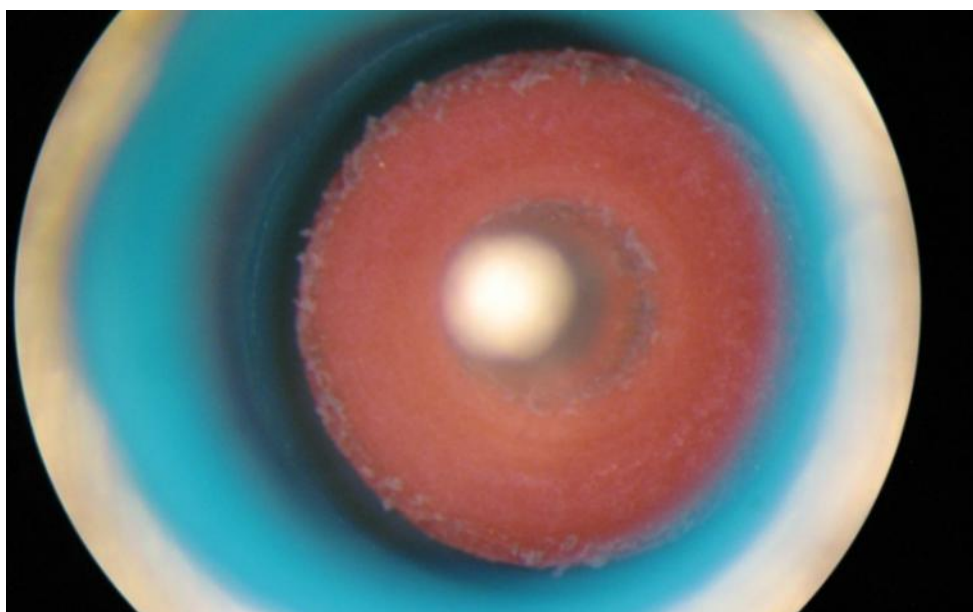
Cleanliness of connector after modified (using soft brush) cleaning process.

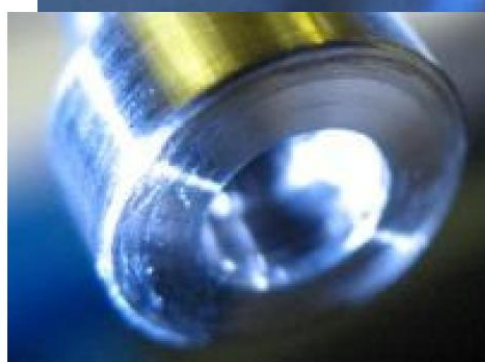
This side appeared to be OK per the separate vacuum leak tests completed even though there were some defects noted in the sealing surface.

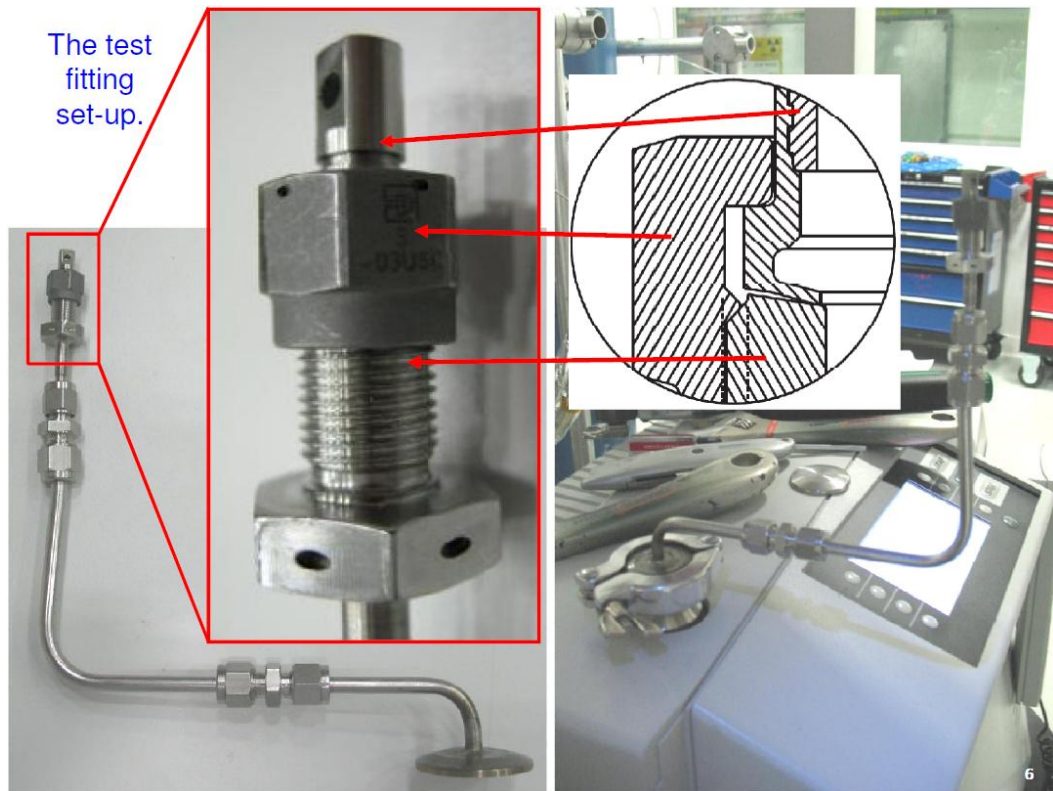
Test Setup↑ and damaged Test Fitting↓
